Case Study

Truxor Weed Clearance and De-Silting

Client - North Lincolnshire County Council

Project - Bottesford Beck

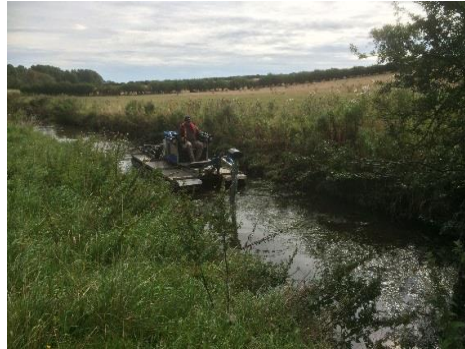
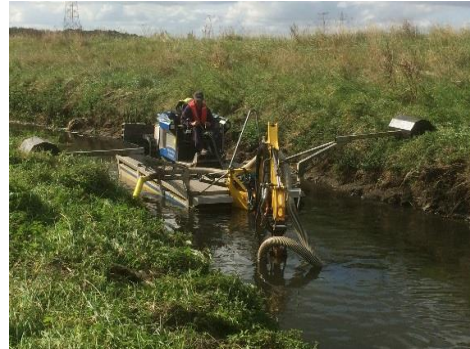
- Beck significantly raised over 10 year period
- Increased inflows in the river were causing erosion
- Extensive sedimentation in sections of the beck
- Large volumes of dense weed causing blockages
- Difficult access and 8,000m linear length

Ebsford initially cleared a central channel of all in water vegetation, the aim of this was to promote flow and direct it away from the banks, slowing down the erosion. Once this was complete, the Truxor machine fitted with a vacuum suction unit removed circa 1,500m³ from the beck. This silt was deposited directly on the side under approval from the EA and after completion of flood consent.
