Case Study

Sediment Management, Dunipace Bridge, River Carron

Client – Falkirk Council

Project - Dunipace Bridge, Falkirk

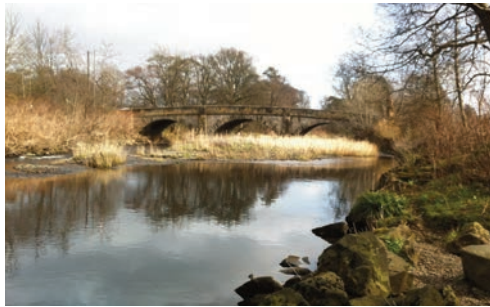
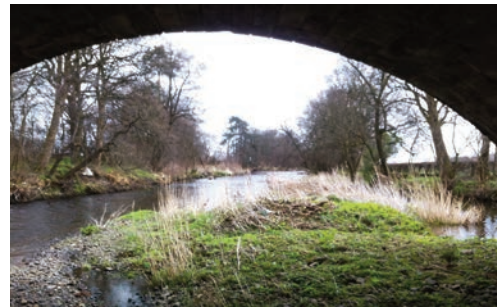
Ebsford developed and deployed a safe and efficient method statement to deal with the complex nature of removing 2000tn of silt from a sediment bar located within the river Carron which also stretched underneath an historic stone bridge.

The sediment island was also contaminated with pockets of Japanese knotweed contaminated soil, requiring separate controlled extraction.

The works required the removal of deposits and the formation of a new bed profile designed to alleviate local and downstream flooding issues as well as securing sufficient site won stone to install as new bank rock armour.

Gaining safe access to the island with a temporary ramp, avoiding contact with the stone bridge and managing the changing water level of the flashy catchment were just some of the main challenges overcome from a safety perspective.
